## FIELD REPORT

Field Report Number	To:	Date / Time of Observations
Field Report #01	Bravo Development	8:30 AM / August 15, 2014
Project		SGS Project Number:
30 Music Square West		14015.00
Present	Bravo Development (owner), Genesis Engineering (Mechanical & Electrical Engineers)

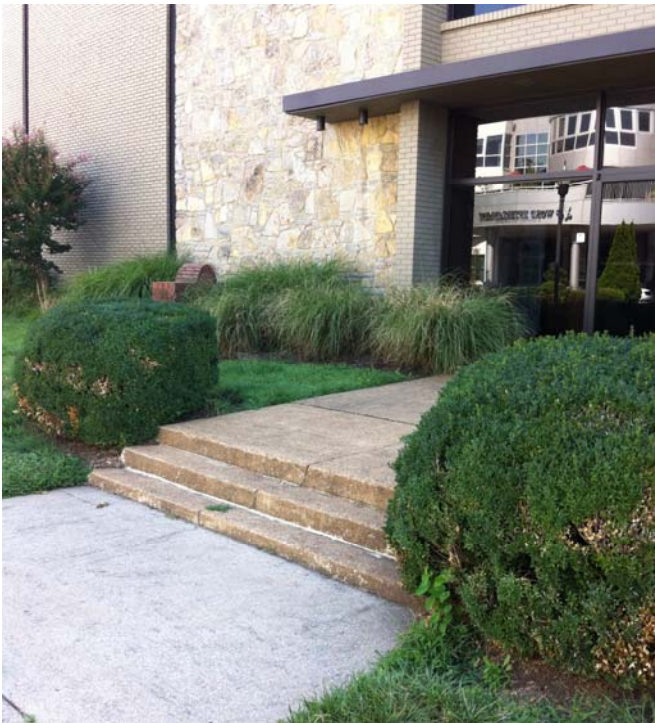
- Entries – Both the front entry from the public right of way and the rear entry that access the existing parking lot are required to allow an individual with disabilities to enter the building. At the front, the existing stairs conflict with that requirement (refer to picture below). At the rear, the existing grading and stairs conflict with that requirement.

Picture #1- Non-accessible Front Entry

The proposed scope of work at the front entry would be to remove some of the existing landscaping and provide a code compliant ramp at the side of the existing stairs. The proposed ramp would need to have a total length of 18 feet +/- to accommodate the grade change.

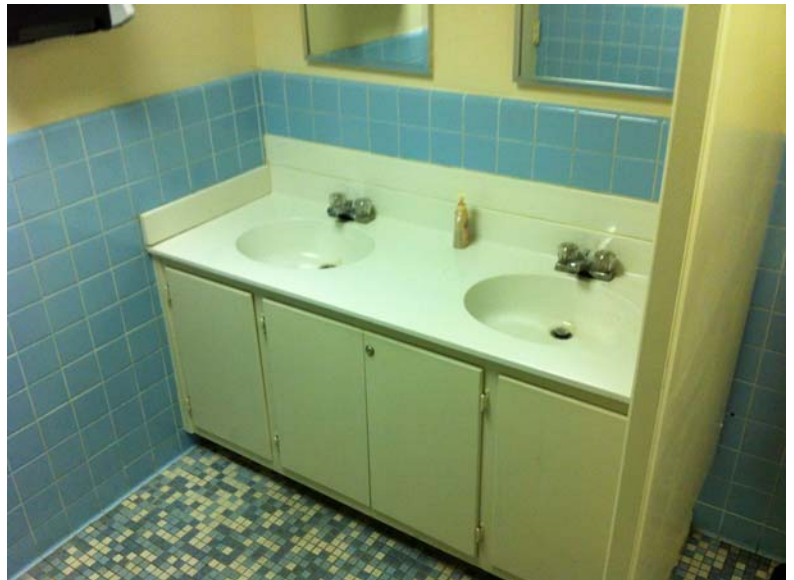
- Public Bath Rooms – None of the public bathrooms provide accessible stalls or accessible sinks fixtures.
- Public Water Fountains – The current location of the public water fountains in the main corridor do not allow for the proper ADA approach, clearances or height. They also create a conflict the code required egress path.

Picture #2 – The current sinks in all public bathrooms do not allow the ADA required clearances below the sink, proper height, and the proper grips on the faucets.

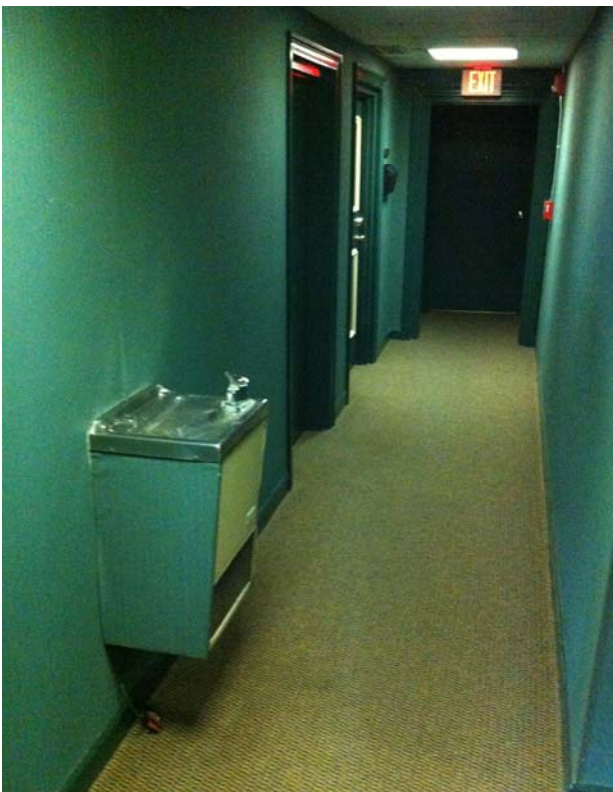
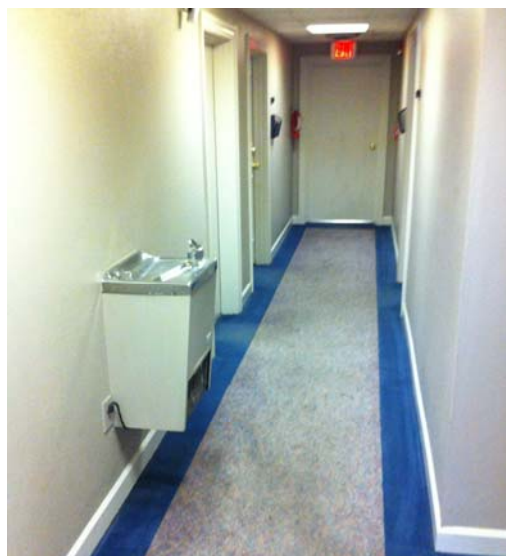
Picture #3 & #4 – The typical Water Fountain location at all three levels do not provide the ADA required height, clearance under fixture or room to allow required approach distance. The fixtures also create a protruding object within the accessible path by more than 4 inches without cane detection. In addition, the fixtures block the emergence egress path.

- As noted in the pictures above, there are obstructions in the corridor that do not allow a free and clear path of emergency egress. None of the existing door hardware meets current codes for easy to operate lever sets. There is no panic hardware or quick release door hardware on any of the exit doors.

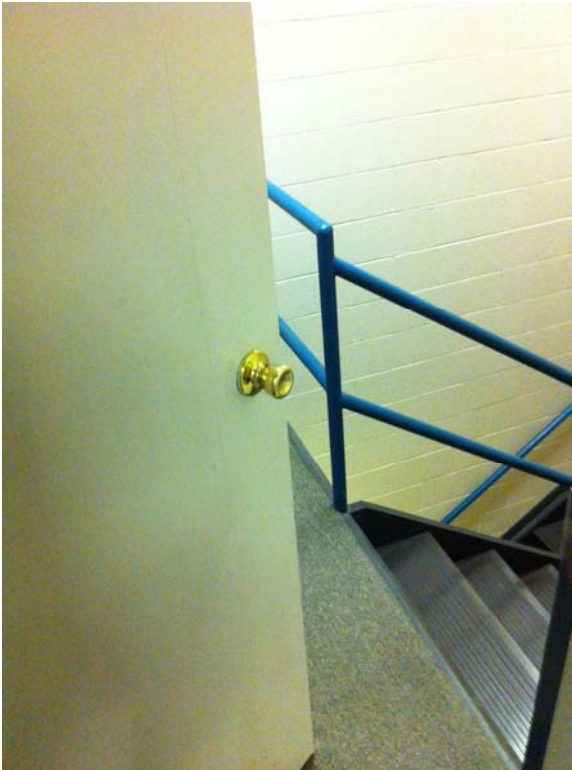
Picture #5 Non-compliant door hardware

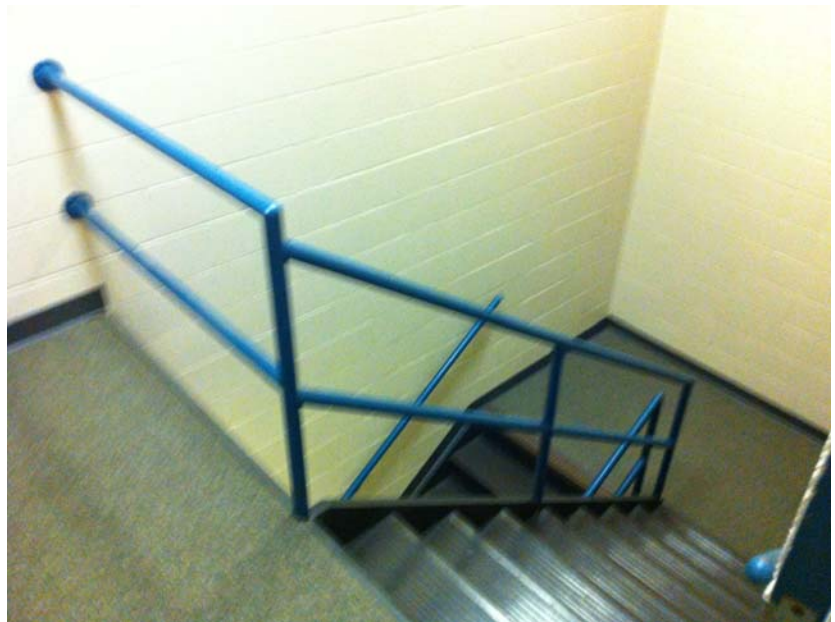
Picture #6 Non-compliant railings

- Current codes require proper height guardrails, handrails with proper extensions, and guardrail pickets that do not allow a 4 inch sphere to pass through. None of these requirements are currently achieved with the current stairs. Refer to pictures above.

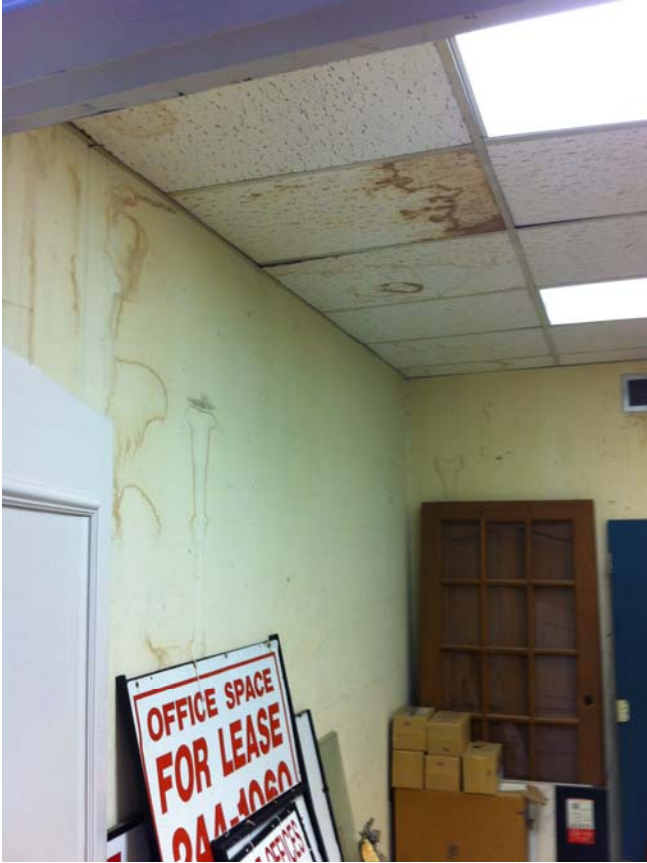
- Above the existing studio space, water damage was discovered. It appears to be caused by a roofing issue where the oldest part of the building intersects the exterior wall/parapet and the office building addition. This leak has caused both interior and exterior damage. The interior damage can probably be repaired relatively easily. However, it appears that the water damage has caused a failure in the brick veneer on the exterior of the building. This is a significant concern because the brick veneer is already becoming detached from the exterior wall and the loose brick is near the main front entry of the building. The existing brick veneer needs to be removed in order to fully assess the damage to the exterior wall. It is likely that the brick ties are rusted. Refer to pictures below.

Picture # 7 – Interior Water damage above studio

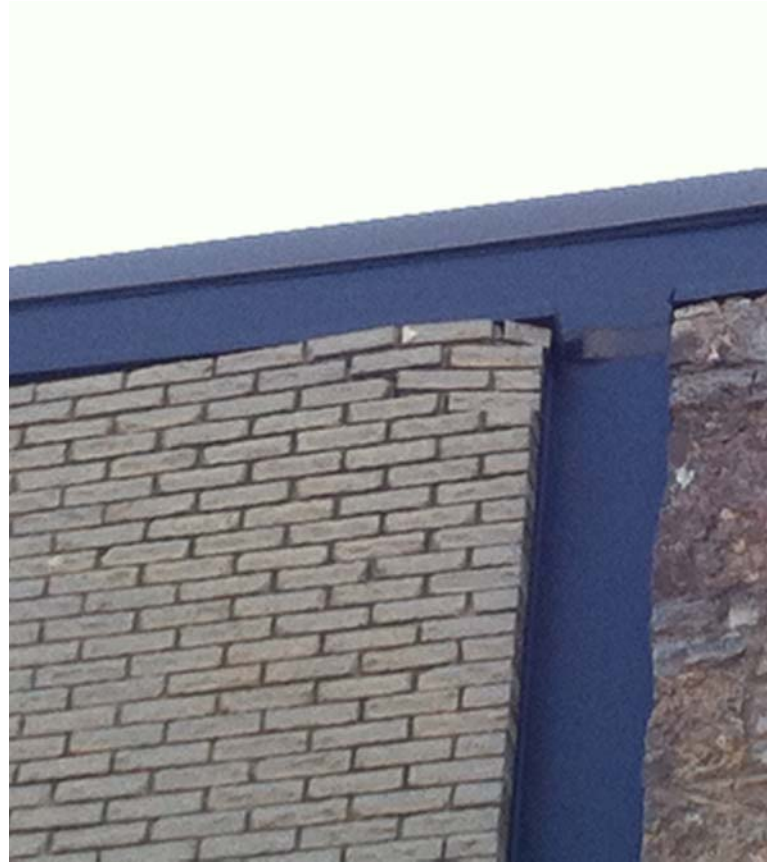
3. **Non-compliant Egress Stairs** – Lack of compliant railings, guard rails, and handrails.
4. **Water Damage at Third Level Roof** – The roof above the existing studio space is leaking at the parapet. This has caused damage on the interior and exterior of the building façade. The damage on the exterior is causing the brick veneer to come detached from the exterior wall. This brick could easily fall and cause a public safety concern.

Picture #8 – Exterior Brick Veneer Failure
